**National Highway
Traffic Safety
Administration**

Case Vehicle (A): 2000 Ford
Type: Expedition Eddie Bauer 4 x 4, 4-door SUV
Driver: 50-year-old female
CDC: 12-FRLE-3

Vehicle (B): 1989 Ford
Type: Taurus LX, 4-door sedan
Driver: 33-year-old female
CDC: 99-0000-0

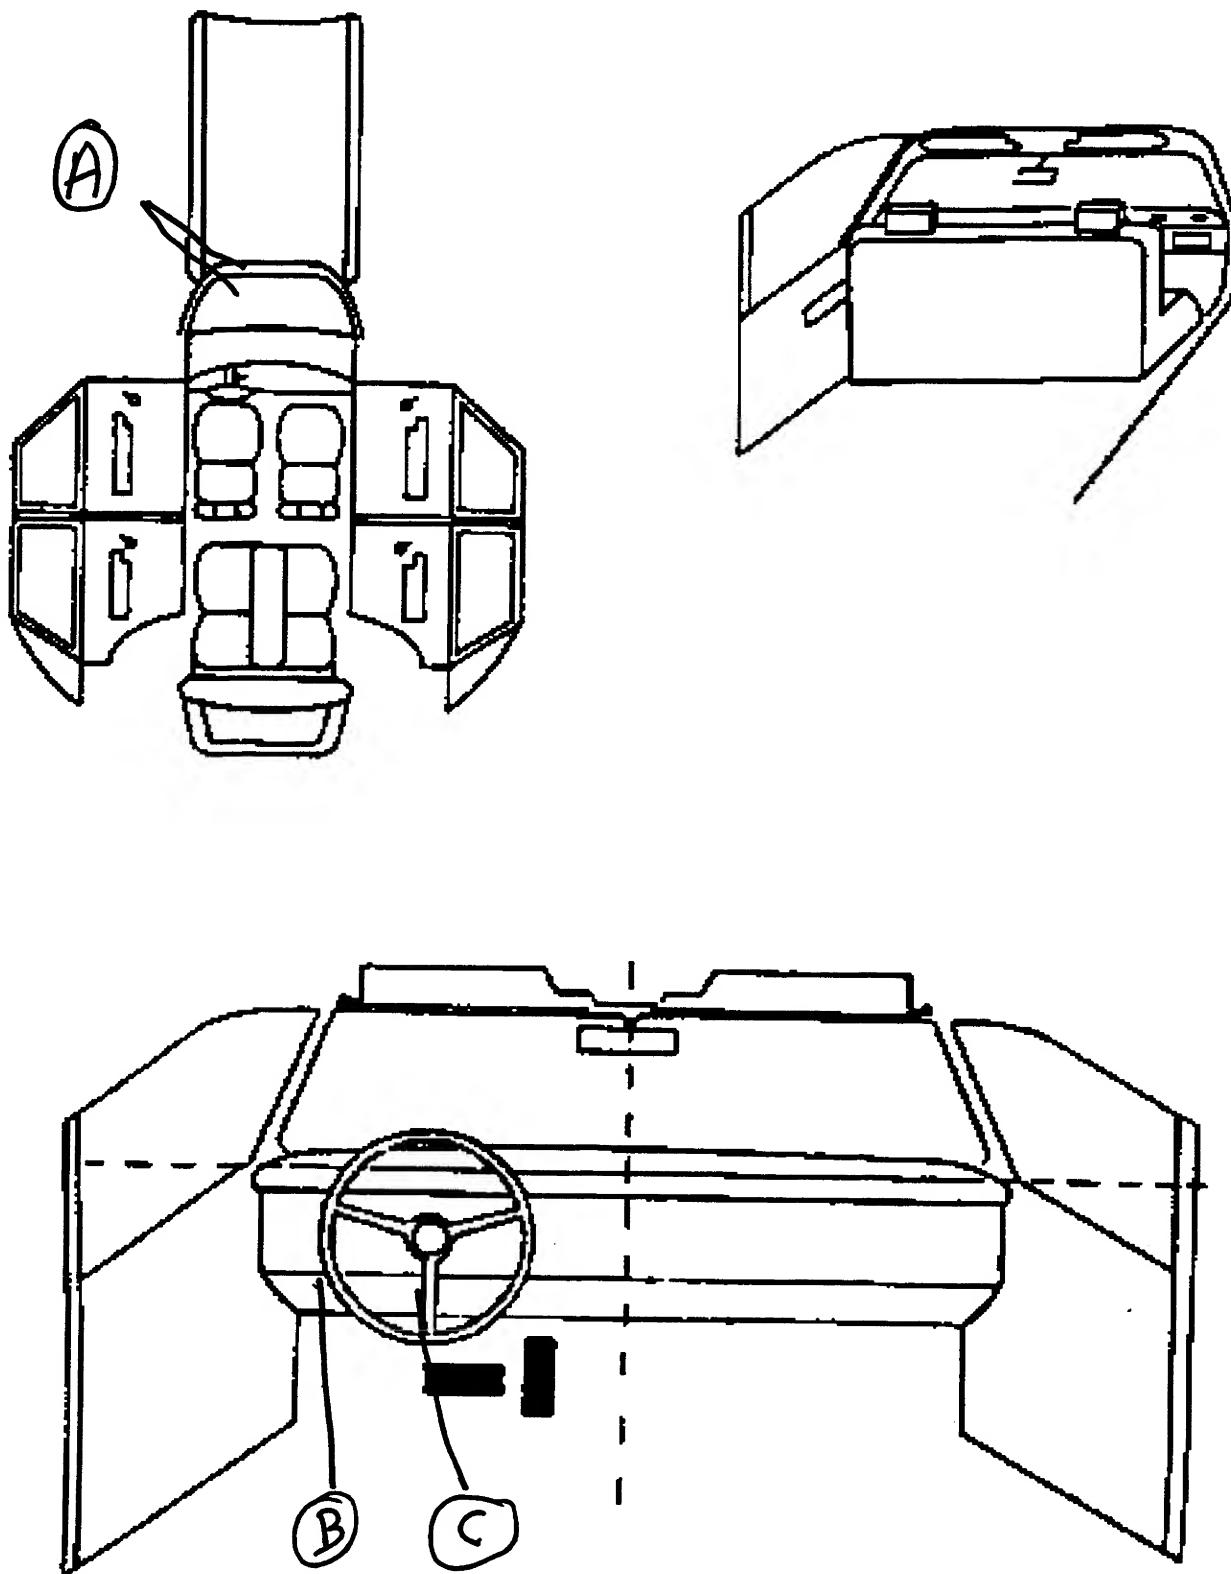
VEHICLE OCCUPANT CONTACT DIAGRAM

Contact	Interior Component Contacted	Occupant No. if Known	Body Region if Known	Supporting Physical Evidence	Confidence Level of Contact Point
A	WINDSHIELD/HEAD	DA	Lt. Hand	windshield cracked (DIAMOND ring)	1
B	KNEE bolster	DA	Lt knee	Dent	1
C	KNEE bolster	DA	Rt knee	Stress mark	1
D					
E					
F					
G					
H					
I					
J
